AAC Publications

Leader Fall on Ice — Poor Ice Conditions, Ice Dam

Canada, British Columbia, Kootenay National Park, Storm Creek

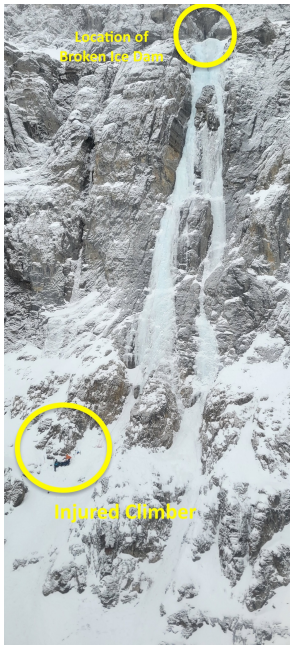
Injured ice climber (yellow circle) at the base of Xena in the Storm Creek area of Kootenay National Park. The ice dam that broke, flushing the climber into a long fall, is marked at the top of the route. Photo: Conrad Janzen, Parks Canada Visitor Safety

On December 2, a climber was nearing the top of a two-pitch ice climb called Xena (100 meters, WI3/4) in the Storm Creek area. They traversed to establish an ice anchor and broke through an ice dam with their tools. The release of water pushed them off the route, and they fell 12 to 15 meters (40 to 50 feet), breaking their right leg. The belayer was also soaked and lowered the injured climber as far as possible. The injured climber built an ice anchor and rappelled to the top of the first pitch. From there, the belayer fixed a rope to and lowered the injured climber to the ground. They then rappelled down.

While ice dams with large amounts of water behind them are not common on ice climbs, a significant number of people have encountered this type of event over the years. They generally form on relatively low-angle sections, often at the top of columns or steep ice. Though this hazard may be difficult to anticipate, it reinforces the need to place good and frequent protection, especially before topping out on a route, even if the terrain is easy. Frequent protection can help minimize the length of a fall and reduce the potential for serious injury.

Injured ice climber (yellow circle) at the base of Xena in the Storm Creek area of Kootenay National Park. The ice dam that broke, flushing the climber into a long fall, is marked at the top of the route.
