### Lead Fall — Ankle Fracture

Alaska, Mt. Hunter, North Buttress, Deprivation route

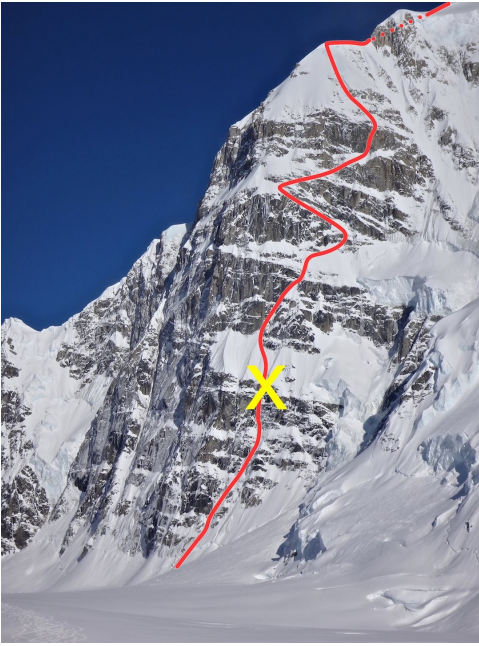
**On May 17, a party of two was climbing Deprivation on the North Buttress of Mt. Hunter when the leader fell approximately 50 feet and sustained an ankle fracture.** The fall occurred on the upper route at roughly 6,400 feet on the Southeast Fork of the Kahiltna Glacier. With assistance from a second party climbing a nearby route, the injured climber's team lowered him eight pitches to the base of the wall and self-rescued to the glacier.

The North Buttress of Mt. Hunter with the line of Deprivation marked in red and the location of the fall indicated with a yellow X.

Parties climbing remote technical routes in the Alaska Range should carry a communication device capable of two-way contact and have a clear plan for self-rescue in the event of injury, since NPS response times from Talkeetna—even under favorable conditions—are measured in hours. The flat-light delay that prevented the helicopter from landing at the scene is a recurring constraint in the range and should be factored into any rescue planning. (Source: Denali Mountaineering Rangers.)
