### Loose Rock — Off-Route, Finger Fracture

California, Sierra Nevada, Mt. Whitney, East Buttress

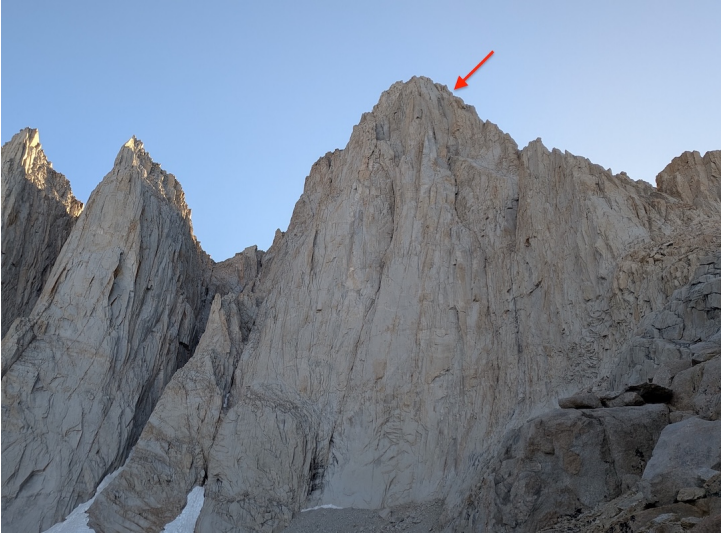
Around noon, I led what I thought was pitch eight—a class 3 traverse, then a short technical move onto a scree field of melon-sized blocks with smaller chunks mixed in, roughly 50 meters long. I built an anchor using a fixed offset nut at the end of the scree field before the climbing again became fifth class. I brought my partner up. Partway through the scree, a block came loose and crushed her right ring finger—later confirmed as a displaced fracture. I heard her cry out; I sent tape down and she made her way up. At the belay, we buddy-taped the finger. We called SAR at 12:30 p.m. to report our situation and our plan to self-rescue—we wanted a backstop if things got worse.

The clear mistake was when we blindly following another party instead of sticking to the topo. We had a contingency plan if we absolutely needed to descend from pitch nine, but I am not sure we could have managed it safely given the abundant loose rock.

The East Buttress of Mt. Whitney is a classic alpine rock route to the highest point in the Lower 48. It was the scene of an off-route incident that contributed to one climber suffering a broken finger (red arrow marks where that happened). The team successfully self-rescued.
