### Ice Dam Collapse — Near Miss

Colorado, Lake City, Mt. Sherman

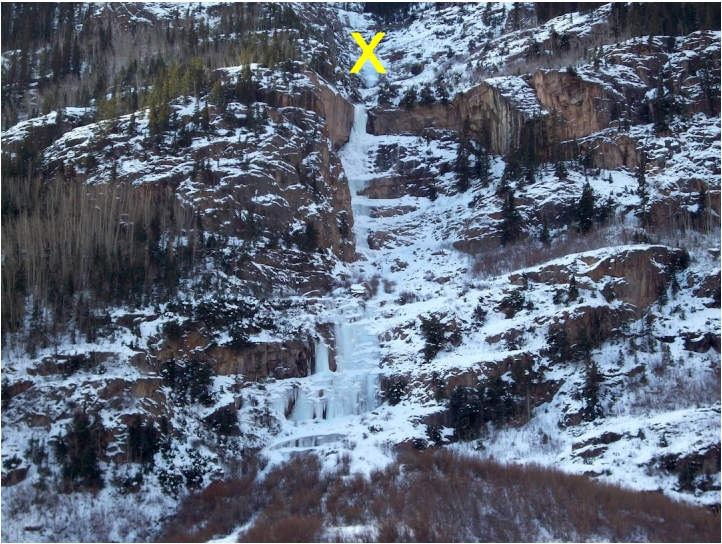
In February 2025, an ice dam broke near the top of Sherman Climb and triggered an avalanche. The yellow X indicates the site of the breakage and subsequent avalanche. Photo: Matt Toensing

In February 2025, an ice dam broke near the top of Sherman Climb and triggered an avalanche. The yellow X indicates the site of the breakage and subsequent avalanche.
