Ptarmigan Traverse Ice Collapse

Washington, North Cascades National Park, Ptarmigan Traverse

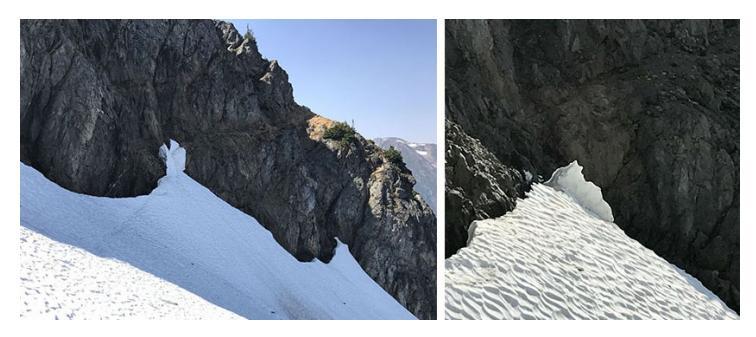
Before (left) and after photos of the ice bridge that collapsed on the Red Ledges traverse.

The extreme heat undoubtedly played a major role in the instability of the icy serac and snow ramp. Visual inspection revealed no obvious problems, except for the snowy cornice, which Stefan climbed past with no problems. There might have been a better way to get through the moat, but the serac could have fallen whichever way we went. Simply put, we were in the wrong place at the wrong time. On the positive side, we made several good decisions by relying on a good, strong anchor, using a backup prusik on the rappel, and wearing helmets. (Source: Ed McCord.)

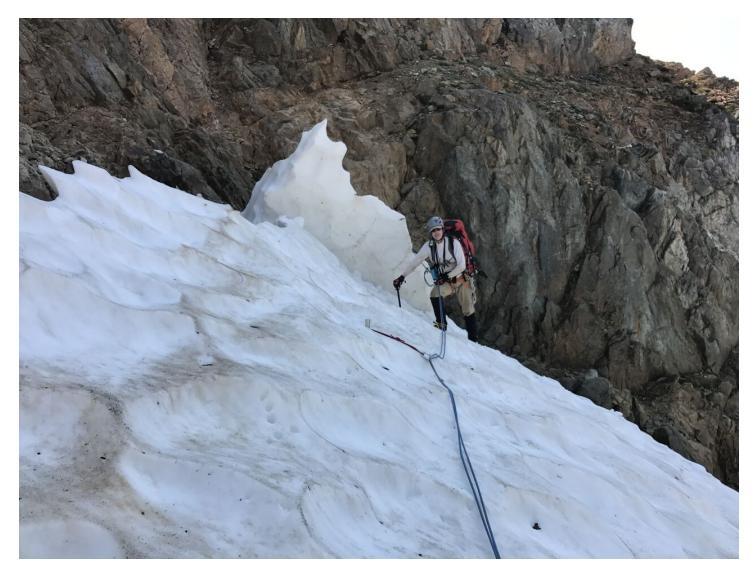
The icy fin in center collapsed and knocked the photographer into a moat just as he rappelled from the Red Ledges above. Fortunately, he had only minor injuries.
