Rappel Error – Device Installed Incorrectly

Wyoming, Grand Teton National Park, Cascade Canyon, Storm Point

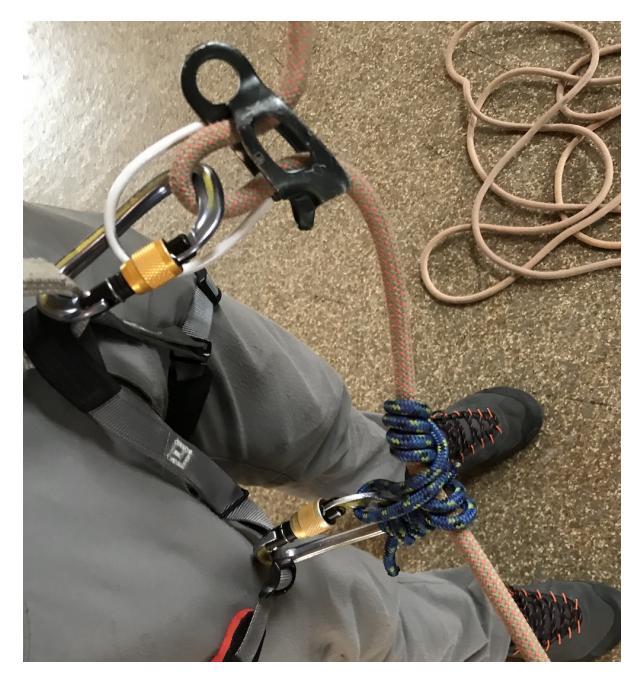
Reconstruction of the rappel setup found on a climber who fell at Guide's Wall. It is believed the climber wrapped the autoblock around both strands of his rappel rope, but he failed to insert one strand of rope through the rappel device and clip it into his carabiner. As soon as he weighted the system, the unclipped strand pulled through the autoblock backup.

The climber was found rigged for rappel with a Black Diamond ATC Guide and an autoblock (i.e., a "third hand") backup, each clipped to his harness with independent locking carabiners. A single strand of the climbing rope passed through the ATC and locking carabiner, which was attached to the harness belay loop. The autoblock, clipped to a harness leg loop, was wrapped around the single strand of rope as it exited the ATC with approximately 190 to 200 feet of rope beyond it. The autoblock was not wrapped around the 30 to 40 feet of climbing rope leading out of the ATC in the

Based on interviews with the partner and the evidence found at the scene, investigators concluded the primary cause of this accident appeared to be a rappel rigging error. The climber appears to have only clipped one of the two strands of rappel rope when attaching his ATC. He was an experienced climber and would not have committed this error out of ignorance. The partner's statement that she had just given him a puffy coat, which he subsequently put on, suggests that perhaps this coat concealed this error. It is likely that a bight of rope was pushed into the ATC but was not captured with the locking carabiner, yet gave the appearance of being properly clipped. Once he committed his body weight over the edge, the bight of rope would have instantly popped out of the ATC.

It may be in this moment that the subject uttered "Whoops," as he would have expected the autoblock backup that he had installed on both ropes to hold him. However, repeated tests during the investigation showed that an autoblock does not hold in this scenario. When only one of the strands of the rappel rope is correctly inserted into the device and clipped to the climber's harness, the climber's weight on that strand will cause the other strand (not clipped correctly) to move upward, toward the anchor. The autoblock will not hold when only one strand is through the rappel device and the two strands are moving in opposite directions. (Source: National Park Service Search and Rescue Report.)

Editor's note: No climbing system, including a friction-hitch backup, is completely foolproof. Once your rappel setup is completed, weight-testing the system **before** unclipping your tether from the anchor will verify that your setup is correct.
