Very Large Avalanche – Riding Alone, Inadequate Gear

Colorado, Front Range, Mt. Trelease

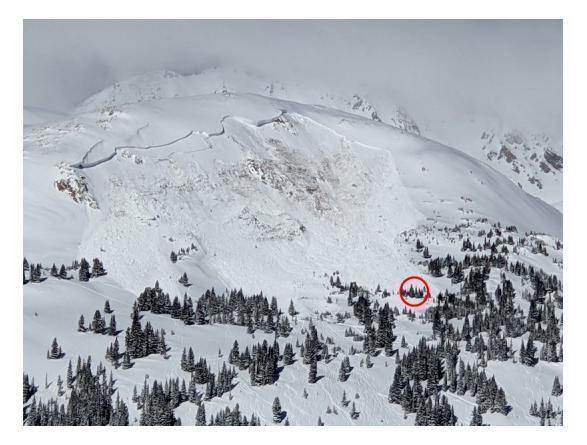
This avalanche overran a well-used skin track and other skier tracks. Position of Rider 2 after the slide is shown.

This avalanche ran over a well-used skin track. During unusual snowpack conditions, "normal" routes and what are considered safe spots must be re-evaluated.
