FALL OVER BERGSCHRUND — Inadequate Route-Finding

Oregon, Mt. Hood, Eliot Glacier

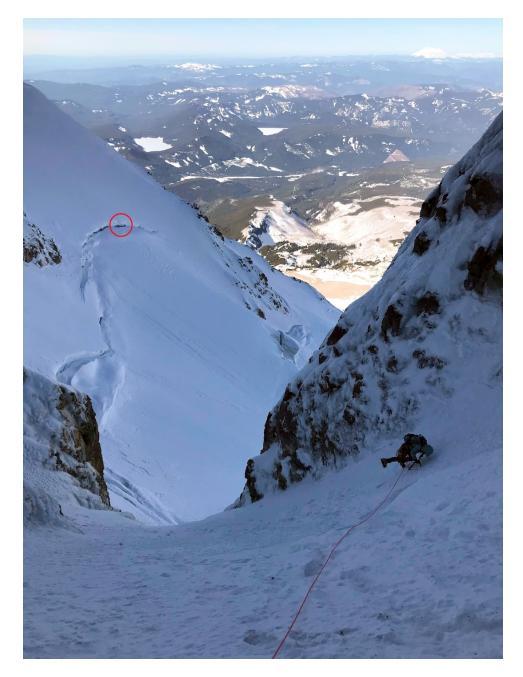
While downclimbing, the lower climber knowingly stepped onto a snow bridge across the bergschrund. The bridge collapsed when fully weighted, and the climber took a small and inconsequential fall into soft snow on the lower side of the bergschrund, which was filled in by winter snow, a short distance below the lip. The force of the fall pulled Person 2 off balance, and they were unable to self-arrest on the firm surface. Person 2 slid down the slope and also fell into soft snow near the edge of the crack.

The circle marks the location of a fall at the bergschrund on the Eliot Glacier of Mt. Hood. Fortunately, neither climber involved was injured.

The climbers believe that the primary mistake was choosing to cross the bergschrund on a snow bridge of unknown quality. Options existed for end-running the crevasse, and, in hindsight, that would have been a much better choice. Being roped together without protection did not add any security to this situation and created significant additional hazard for the second climber. (Source: Person 1.)
